Introduction

Failure analysis expert witness performs a root cause failure analysis on a wine bottle that was involved in a personal injury lawsuit. The glass expert examines the fracture surfaces to trace back to the failure origin. Microscopic examination of the failure origins shows that the failure was not the result of a manufacturing defect. The bottle failure was caused by improper use of a corkscrew. In this failure there are two initiation sites. Each initiation event was caused by interference of the corkscrew with the inner wall of the bottle neck.

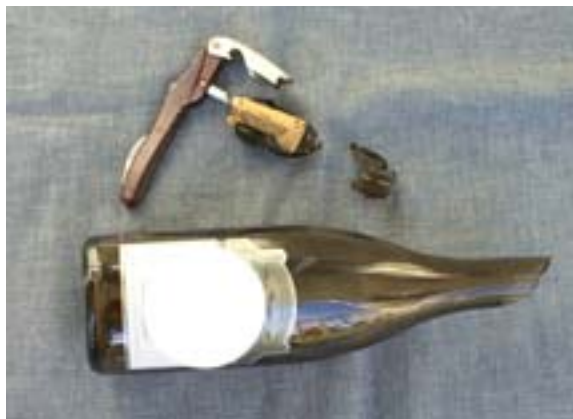
The bottle failure is shown in Figure #1. There are three separate fracture pieces. Two smaller pieces are from the neck and the other the remainder of the bottle. The neck had broken open, and one piece still contains the cork with the cork screw. The other half of the neck is a separate piece. This failure had two initiation sites. On one side of the neck has the first crack initiation site (Figure #'s 2, 3 & 4). This primary damage was caused when the corkscrew was first inserted on one side of the cork (Figure # 4) and the corkscrew tip damaged the inner wall of the bottle. The user must have noticed that the corkscrew was stuck and withdrew it to retry insertion. He then restarted the corkscrew on the other side of the cork. As a result of this action there is crush damage (Figure #'s 5 & 6) created by the side of the corkscrew being driven into the glass when the corkscrew was being screwed in and when the cork was being withdrawn. Both insertions were not centered, and both insertions created damage on the inner wall of the bottle neck that initiated cracks that grew as the cork was being extracted.

Figure #1: Overview of the failed bottle. There were three separate pieces. Two pieces were from the neck and the other the remainder of the bottle. The neck had broken open, and one piece still contained the cork with the cork screw still in it.

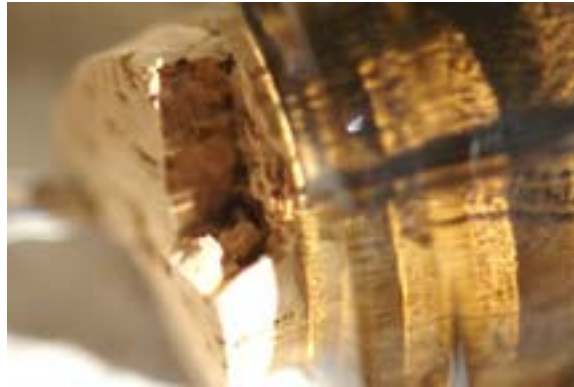
Figure #2: Photograph of the other side of re-assembled neck. This shows the fracture on the opposite side of the neck. In this case the two halves of the fracture are pushed together.

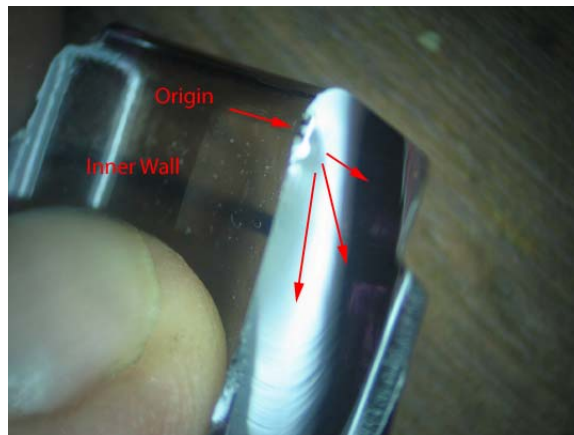
Figure #3: Photograph of one half of the fracture shown in Figure #2. This crack was initiated by damage from the corkscrew tip. It appears that the corkscrew was inserted twice. The first time the point hit the inner wall of the neck near the top and initiated a crack that was later opened when an attempt was made to withdraw the cork. After initiating this “first” crack, the corkscrew was withdrawn and re-inserted. The arrows show the travel direction of the crack.

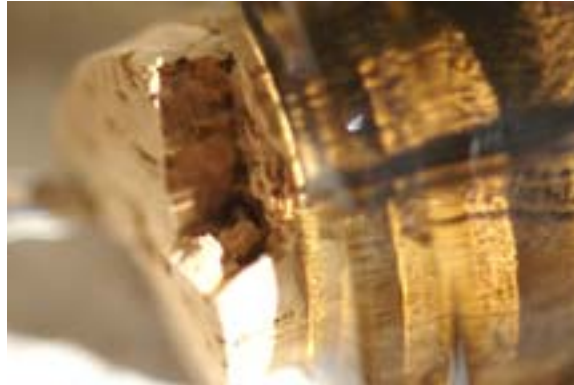
Figure #4: Close up of the top of the bottle near the second fracture. This shows the damage to the cork when the corkscrew was first inserted.

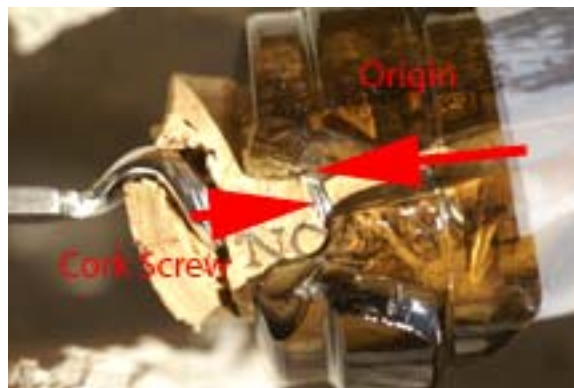
Figure #5: Photograph of the re-assembled neck. This shows the second fracture on one side of the neck. This failure was caused by the side of the corkscrew being driven into the inner wall of the bottle. The two halves of the fracture are parted because the cork has expanded since it is no longer squeezed in the neck.

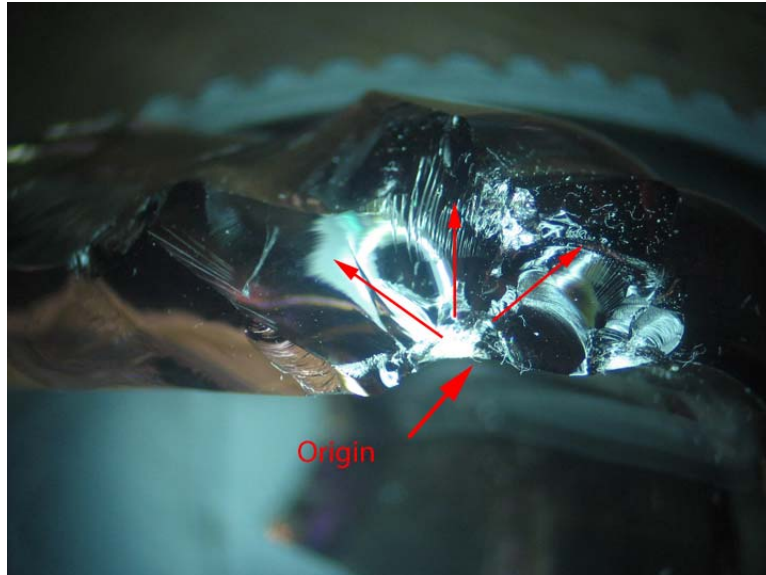
This bottle failed as a result of damage to the inner wall of the neck from improper use of the cork screw.

Figure #6: Low power photomicrograph of the origin of fracture initiation site #1. The fracture initiated on the inner wall of the bottle due to contact with the side of the corkscrew. The forces resulting from inserting the corkscrew and pulling the cork out with the leverage generate by the action of the corkscrew has crushed the glass on the inner wall of the bottle neck. This initiated this failure (Mag 20 X).
