Introduction

Failure analysis expert witness performs a root cause failure analysis on a wine bottle that was involved in a personal injury lawsuit. The glass expert examines the fracture surfaces to trace back to the failure origin. Microscopic examination of the failure origins shows that the failure was not the result of a manufacturing defect. The bottle failure was caused by improper use of a corkscrew. In this failure there are two initiation sites. Each initiation event was caused by interference of the corkscrew with the inner wall of the bottle neck.

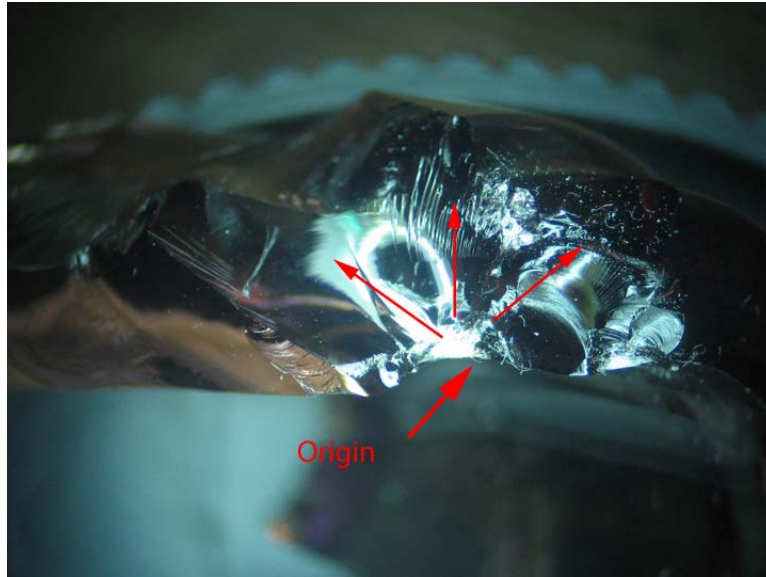
This bottle failed as a result of damage to the inner wall of the neck from improper use of the cork screw.

Figure #6: Low power photomicrograph of the origin of fracture initiation site #1. The fracture initiated on the inner wall of the bottle due to contact with the side of the corkscrew. The forces resulting from inserting the corkscrew and pulling the cork out with the leverage generate by the action of the corkscrew has crushed the glass on the inner wall of the bottle neck. This initiated this failure (Mag 20 X).
